# Safety Inspection Report

Annual Inspection

Brill Parish Council

13 June 2023

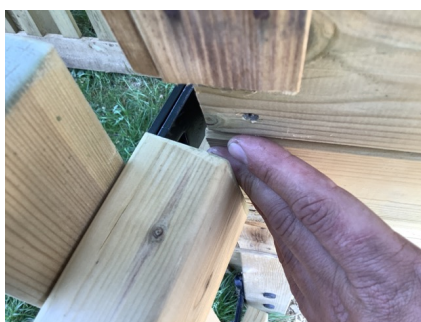
There is a crushing or shearing point on the side of the gate. Where the gaps reduce to less than 12 mm these have been known to cause serious, permanent injury to children, especially on the hinge side where the leverage forces are significant.

Adjust gate / posts / fit new rubber buffer to ensure a spacing of at least 12 mm throughout the range of the gate to remove the entrapment. The 12 mm gap also should apply on the hinge side of the gate.

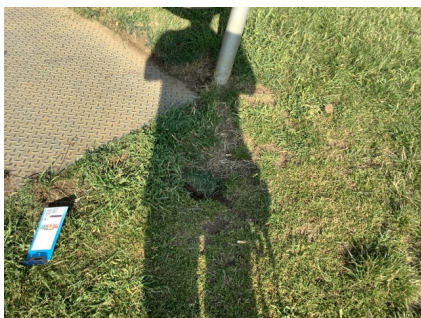
Ground erosion present.

Consider adding grass matting to prevent wear.

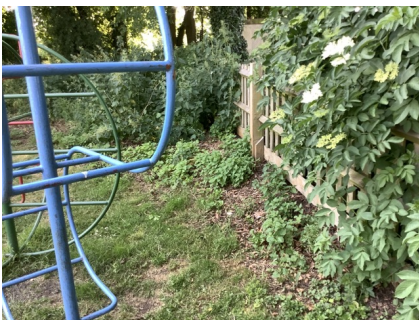
The free space and / or falling space contains obstacles or equipment parts that are not permitted.

Fence within falling space.

Read the notes for further action., Modify.

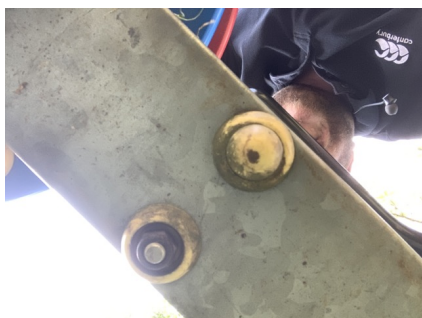
Cap missing.

Replace.

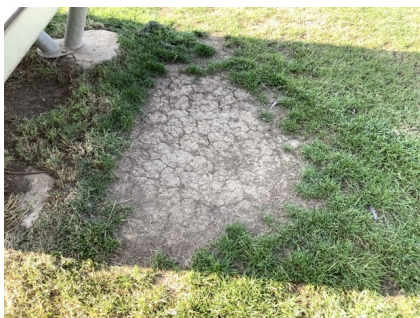
Worn ground areas.

Make good.

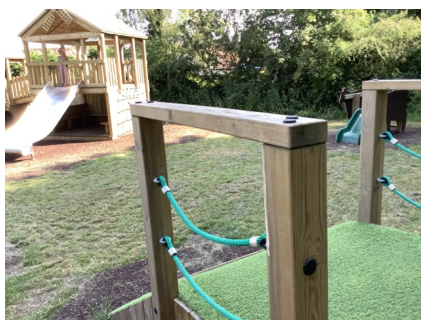
The design of the top of the barrier encourages children to stand or sit on them.

Refer to manufacturer for comment.

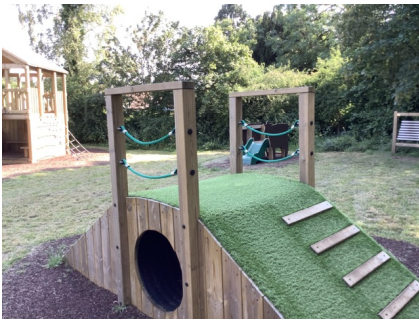
Horizontal guard rails without vertical or solid infill.

Refer to manufacturer for comment.

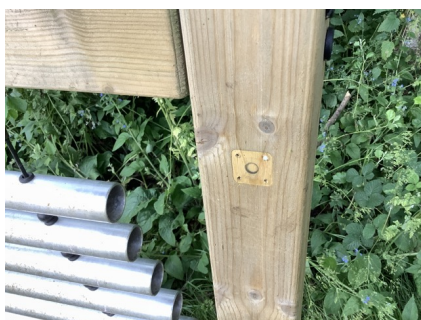
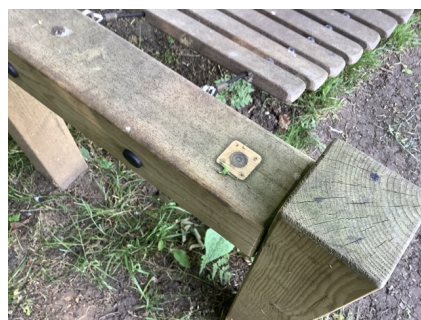
Item has some parts missing.

Beater missing.

Replace the missing parts.

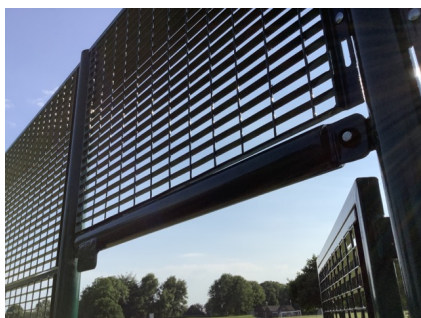
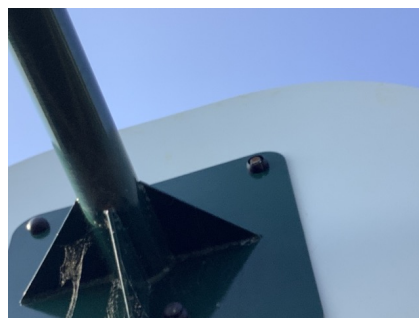
Cap missing.

Replace.

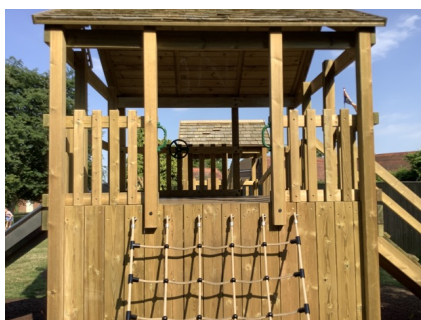
The opening in the barrier on this easily accessible steep play element is wider than 500 mm.

Install appropriate barriers of a minimum height 700 mm., Modify to comply.

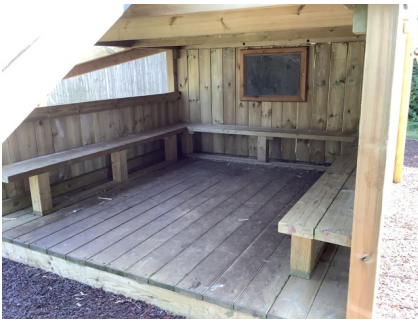
Openings to enclosed equipment with an internal distance greater than 2000 mm without at least two access points.

Refer to manufacturer for comment.

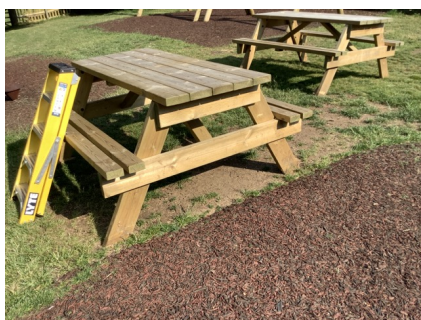
Portable equipment must remain outside the minimum space of the permanently installed items. Free movement of children within the play area may be affected. Without effective control the risks will increase.

Monitor and control the placement of portable items.

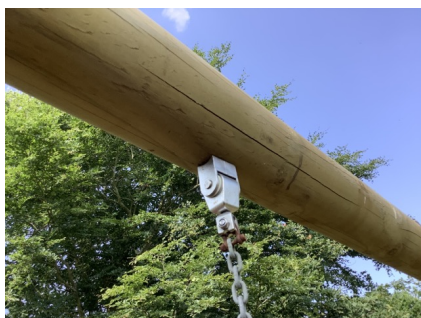
Fixtures loose or missing.

Swing shackles loose on crossbar.

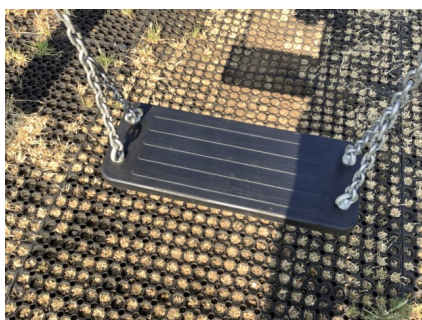
Swing seat bolt(s) loose.

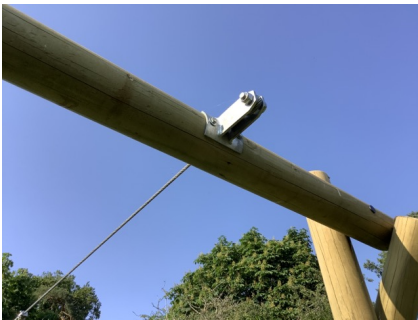
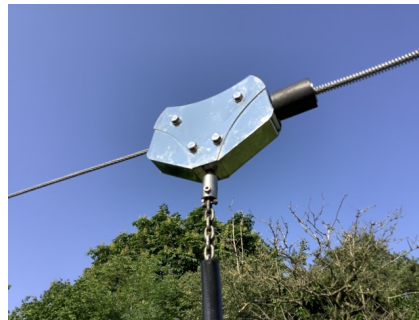
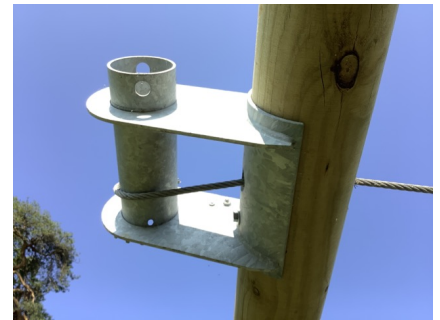
Cables have been known to fail under load due to wear and corrosion. This is generally where the cable enters into a tube, top bar, sleeve or similar, where the wire is in contact and wears and frays over time, but can happen anywhere on the cable. It is important to inspect any hidden parts at least annually. Damaged cables require replacement. This cannot be determined during an annual inspection, and is excluded from our inspection. This can lead to a high risk if no action is taken. Refer to the manufacturer's instructions to ensure the correct check is carried out.

Conduct an appropriate dismantling inspection according to the manufacturer's instructions, and at least annually. The trolley mechanism can be checked at the same time., Refer to manufacturer.

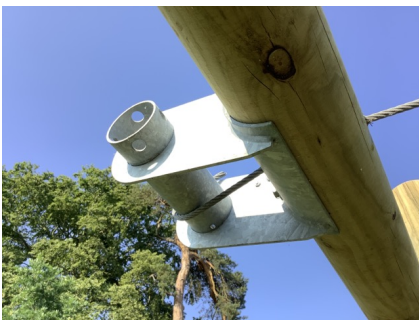
Rospa and most manufacturers recommend a minimum of two rotations of wire around the fixing sprocket.

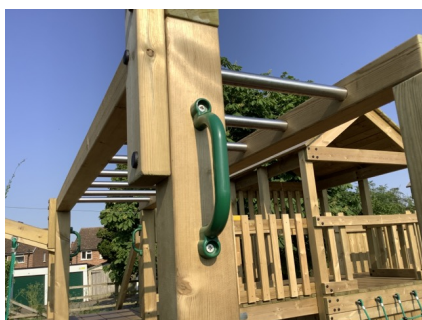
Cap missing.

Replace.

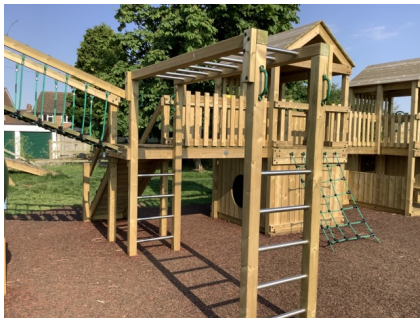
The protective surface under all bars and rings must be kept in good condition.
