# Safety Inspection Report

Annual Inspection

Brill Parish Council

13 June 2023

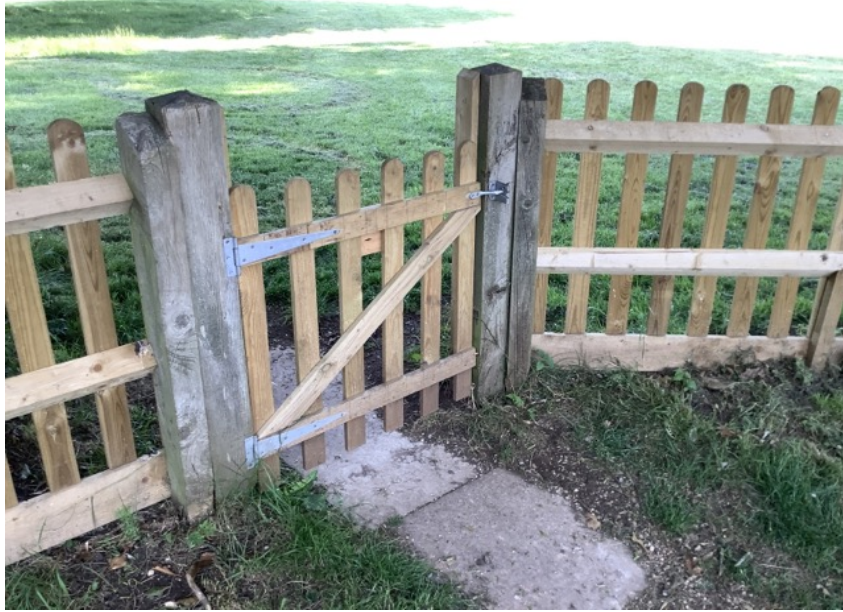
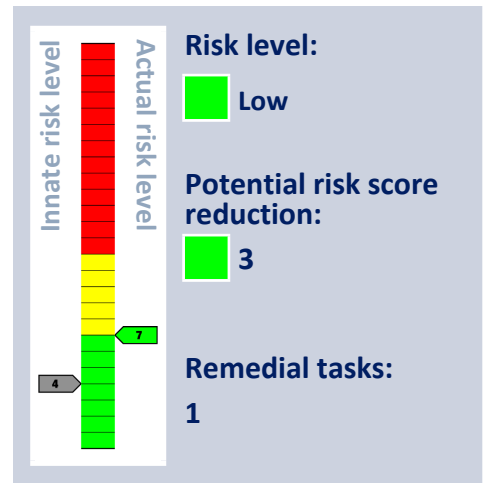
# Gates

There is a crushing or shearing point on the side of the gate. Where the gaps reduce to less than 12 mm these have been known to cause serious, permanent injury to children, especially on the hinge side where the leverage forces are significant.

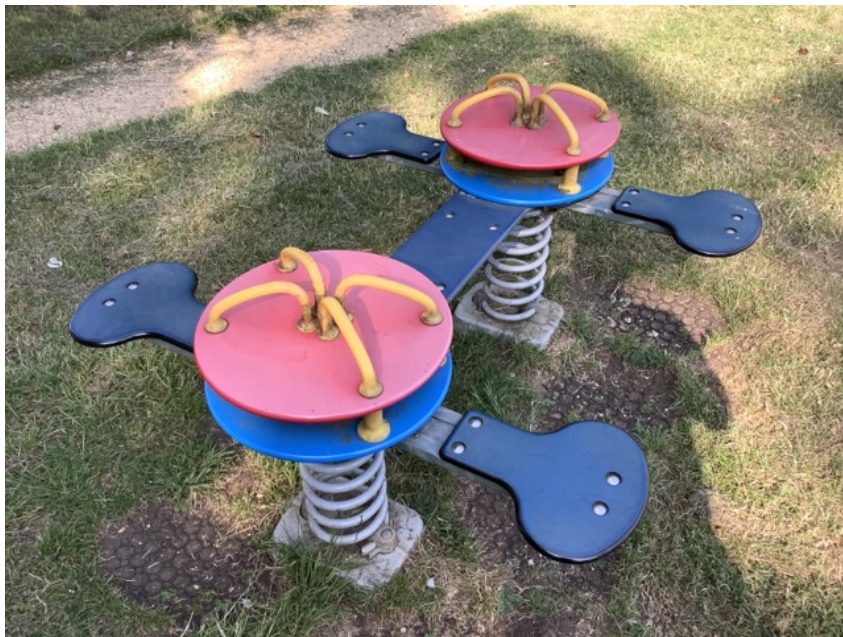
# Rocker - Seesaw - Spring

Cap missing.

Replace.

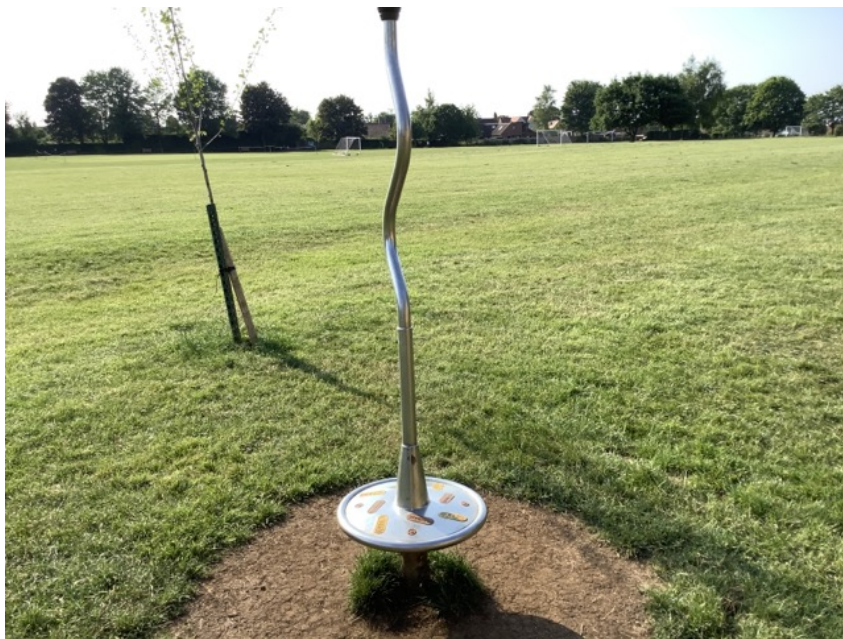
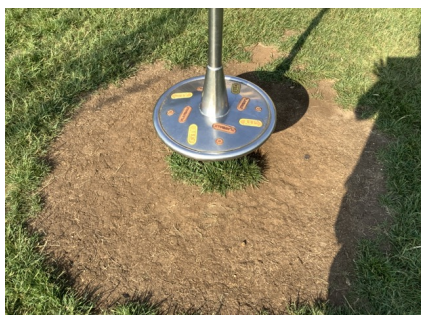
# Rotator - Pole

Worn ground areas.

Rocks exposed. Build up ground levels and consider installing grass mats to help with wear.

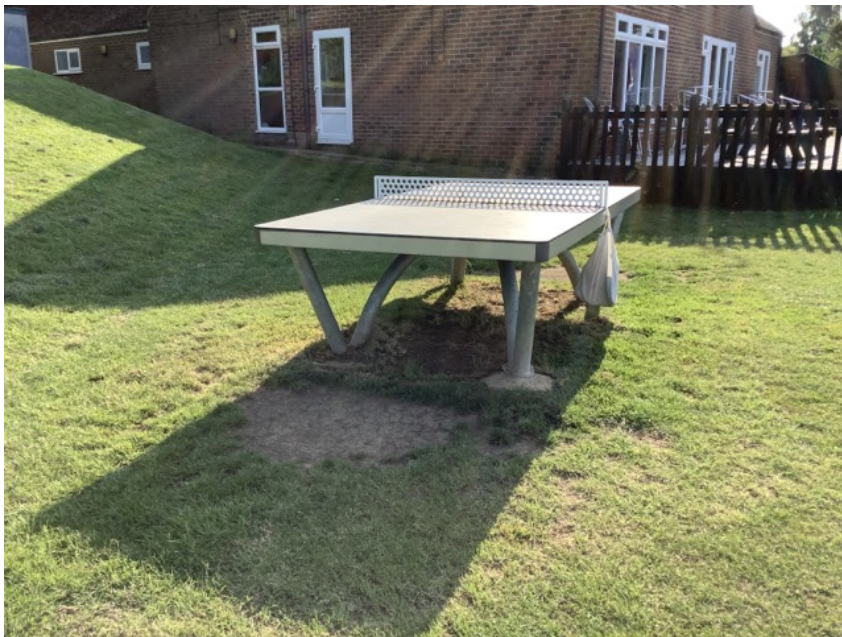
# Table Tennis Table

Worn ground areas.

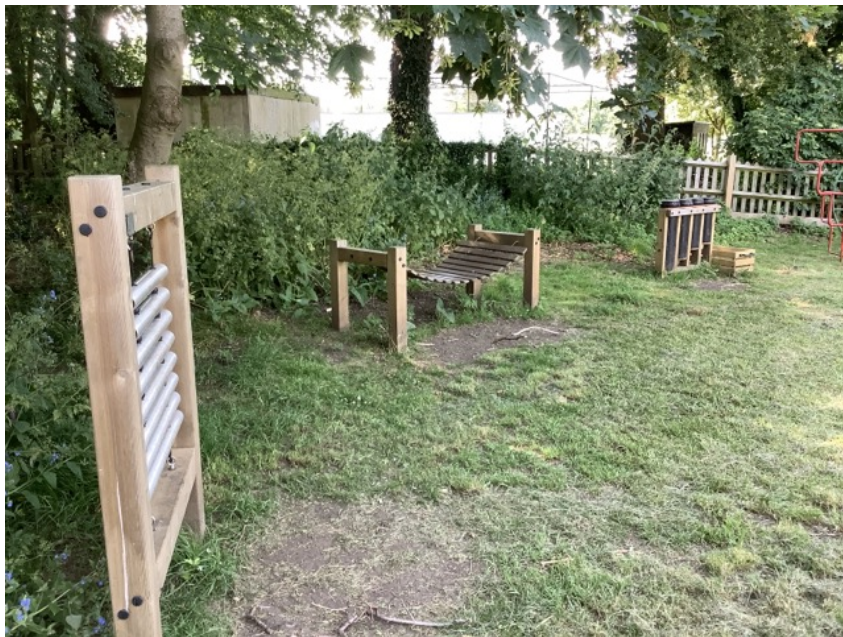
# Play Feature - Musical x 3

Item has some parts missing.

Beater missing.

Replace the missing parts.

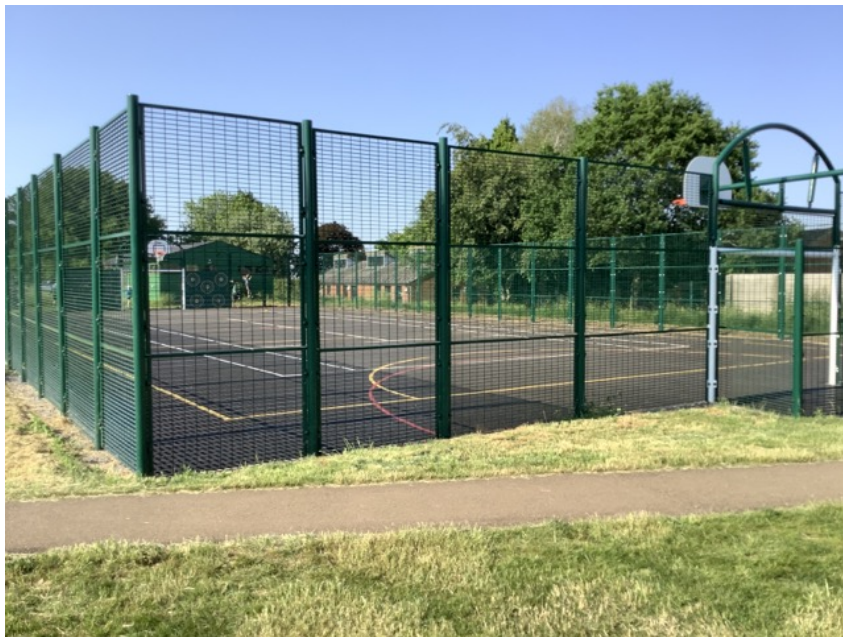
# MUGA

Cap missing.

Replace.

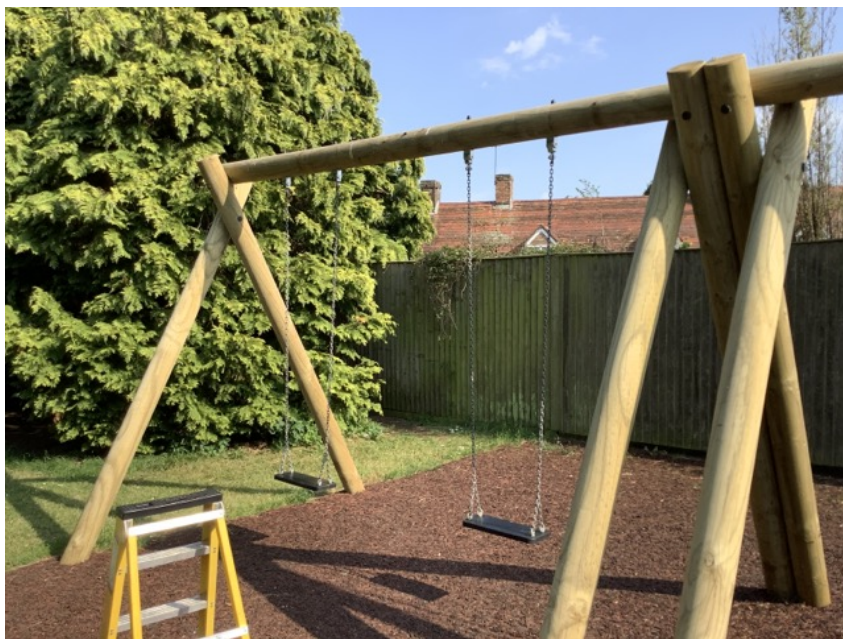
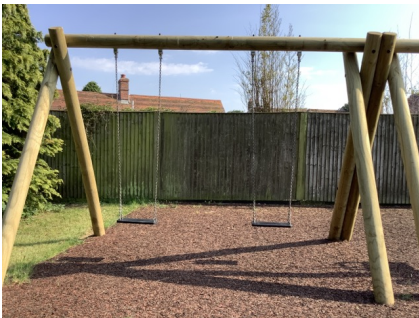
# Swing - Junior - 1 Bay 2 Seat

Fixtures loose or missing.

Swing shackles loose on crossbar.

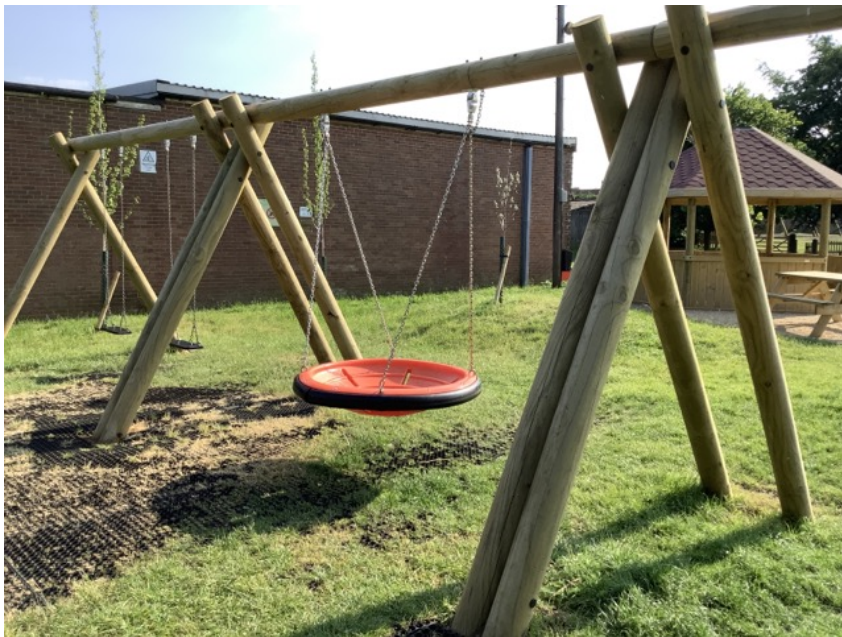
# Swing - Basket

Cap missing.

Replace.

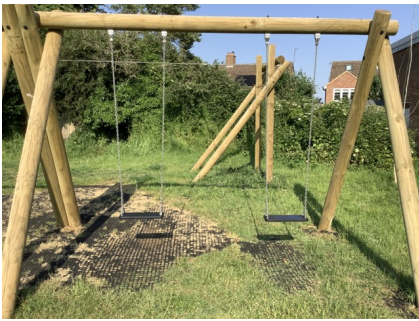
Swing seat bolt(s) loose.

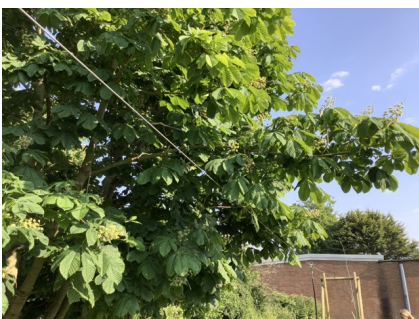
Cables have been known to fail under load due to wear and corrosion. This is generally where the cable enters into a tube, top bar, sleeve or similar, where the wire is in contact and wears and frays over time, but can happen anywhere on the cable. It is important to inspect any hidden parts at least annually. Damaged cables require replacement. This cannot be determined during an annual inspection, and is excluded from our inspection. This can lead to a high risk if no action is taken. Refer to the manufacturer's instructions to ensure the correct check is carried out.

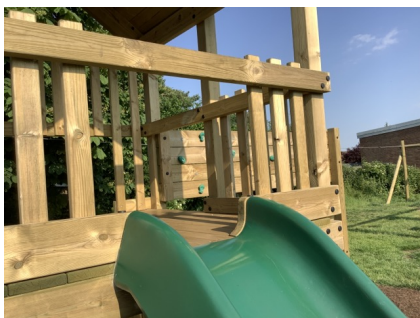
Cap missing.

Replace.
